Veloudaki, C & Theodossopoulos, D 2020, Oria Kastro on Kythnos: analysis of the built remains. in *Seventh Annual Conference on Construction History April 2020: Iron, Steel and Buildings: The Proceedings of the Seventh Conference of the Construction History Society*.. Cambridge, pp. 235-248.
<<https://www.arct.cam.ac.uk/research/history-theory/building-histories/the-seventh-annual-conference-of-the-construction-history-society/conference-proceedings>>

Oria *Kastro* on Kythnos: analysis of the built remains

Christianna Veloudaki¹ and Dimitris Theodossopoulos²

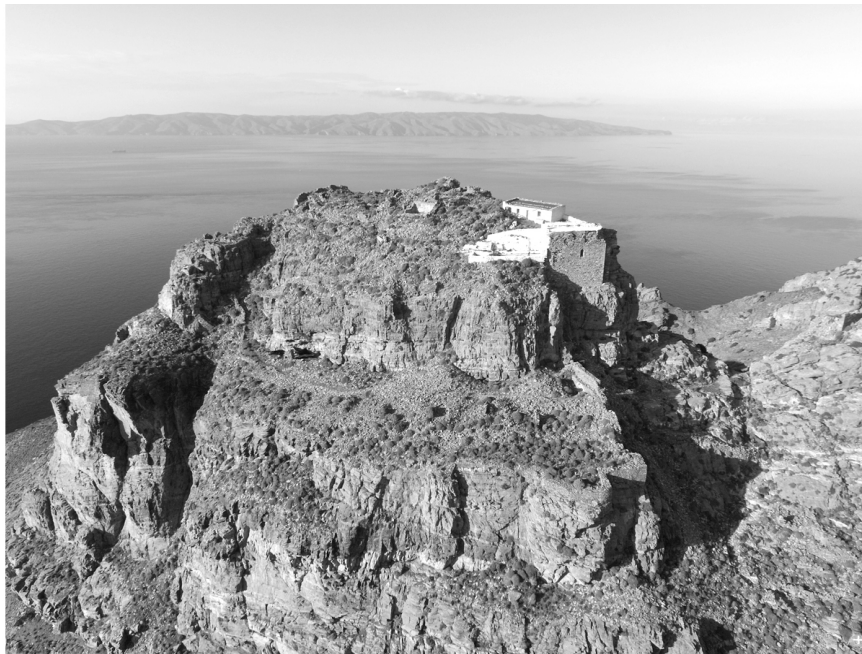
Fig. 1. Aerial view of Oria Kastro (C. Veloudaki).

Oria *Kastro* on Kythnos in the western Cyclades (Fig. 1) belonged to this type of insular strongholds. Built on a remote cliff in the north-western part of the island, it has traditionally been considered Kythnos' medieval capital, founded in the early Byzantine period (ca. seventh century AD) [2]. What we currently see, however, is predominantly the Latin phase as in the early thirteenth century Kythnos was among the islands conquered by Marco Sanudo and his comrades following the Fourth Crusade [3]. At first, the island was under the direct rule of the Duke of Naxos, but later it was ceded to the Gozzadini, a noble family from Bologna. The Gozzadini held Kythnos for almost three centuries (1336-1617) leaving their mark on its built environment [4].

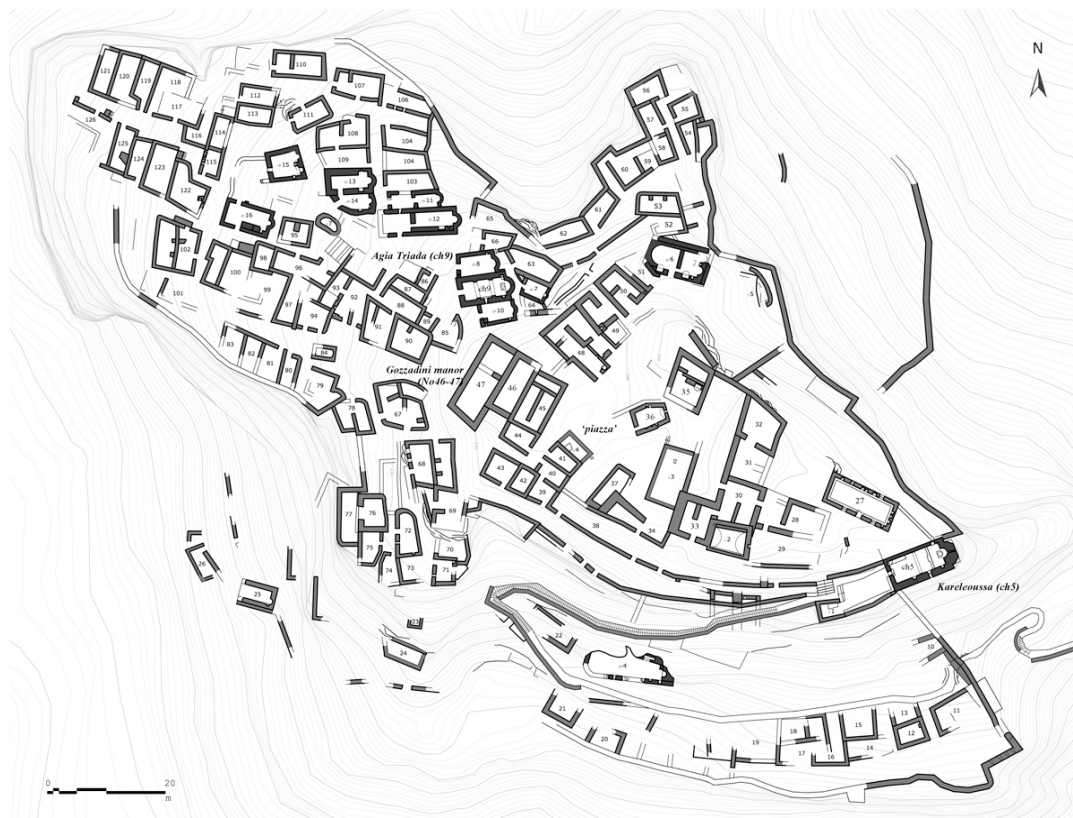
Oria *Kastro* was built in a naturally fortified location, on top of a rugged headland, at an altitude of 250 metres from sea level. At its more vulnerable parts, however, it was protected by double walls at different levels. Both the lower and the upper enceinte wall followed the contours of the terrain, effectively incorporating natural features, e.g. crags and cliffs to the defences. They were equipped with rows of loopholes and at certain points further strengthened with peripheral towers. A total of 137 buildings have been recorded in the intramural area, but that number would rise if systematic cleansings and excavations were ever to be conducted. (Fig. 2)

Fig. 2. Oria Kastro site plan (C. Veloudaki).

Except for the walls and their peripheral towers, in the *Kastro* there are three more structures that seem to have had defensive character (No33, 35, 46-47). (Fig.2) Positioned at strategic locations buildings No33 and 35 have almost square floor plans and thick walls bonded with mortar. Presumably one of them was the so-called *donjon*, the central tower that since the Late Byzantine era formed the castle's last line of defence, to which the defenders would resort when the enemies entered the town. Buildings No46-47 most likely corresponded to the lord's fortified residence. Even though they were solidly built, the state of preservation of all defensive buildings is particularly poor. It is possible that they were all deliberately destroyed after the fall of the town to the Ottomans [8].

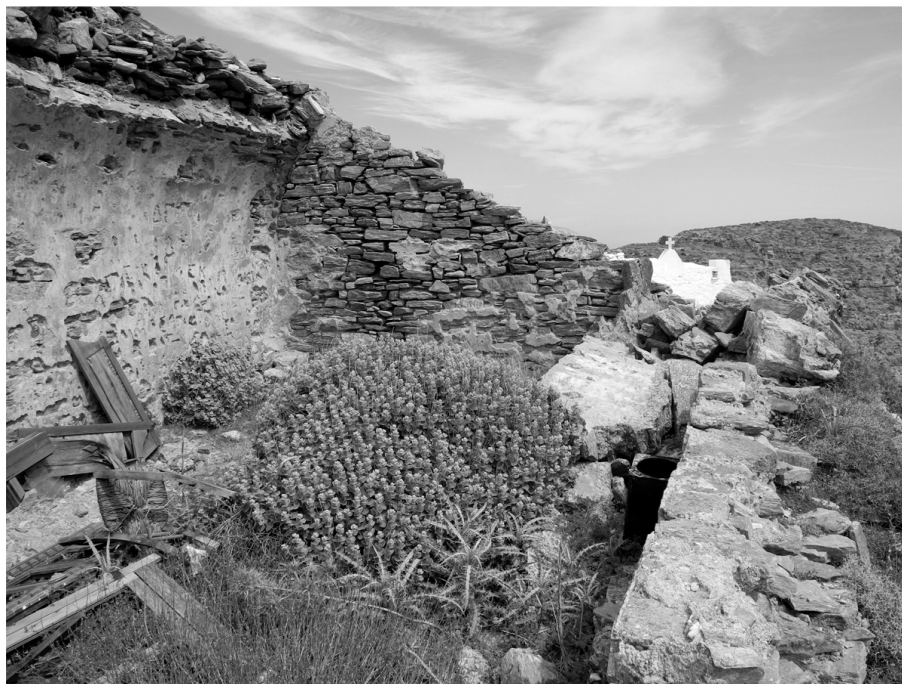
Several cisterns in various forms and sizes (area ranging from 0.6 to 40 square metres, spans 0.8-4 metres) have been recorded in Oria. (Fig. 3) They were solidly built and as a result some of them are preserved almost intact. They are covered with barrel vaults that have a small rectangular opening (~35x60 centimetres) at the top. How the runoff water was channelled into the cisterns is unclear. The gutters and channels that would certainly have existed have either collapsed along with the upper floors of the buildings or are nowadays covered by rubble and soil build-up.

Fig. 3. Remains of cistern (c2) (C. Veloudaki).

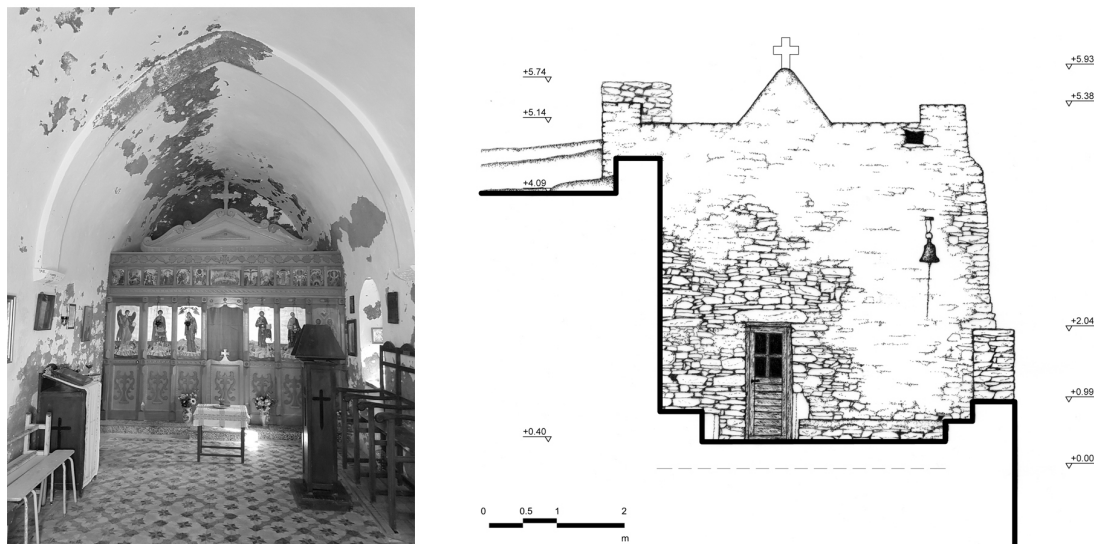
Fig. 7. Kareleoussa interior and west elevation (C. Veloudaki).

Kareleoussa is a single-aisled building with internal dimensions of ~9x4 metres, which correspond approximately to 26x11.5 Venetian feet (1 *piede* = 0.348 metres). It was built with roughly hewn medium-sized rubble stones bonded with white lime mortar. Smaller blocks were used as pinnings to achieve a rudimentary coursing. The church was coated both externally and internally. Given that it was a key part of the upper-level fortifications, its walls are of different thickness ranging from 0.7 metres on the west side to 2.4 metres on the east. The construction, especially on the exposed south and east sides, is more elaborate using bigger, regularly hewn quoins. Semi-finished headers and stretchers were also used for all the openings.

The nave was accessed through a central opening on the west side. In the south wall were two identical, symmetrically placed, arched windows. Their plan (widening both towards the interior and the exterior) is unique for the *Kastro* and shows some degree of refinement. The sanctuary apse is semi-circular with a poros stone cornice and a small window. The voussoirs on the face of the apse are also made from dressed poros blocks. Although currently covered with a coarse cement layer, all hewn poros features would originally have remained uncoated in contrast to the rest of the interior. On the outside, the apse has a rather irregular form. Its base is rectangular, as in other contemporary Catholic churches (e.g. the cathedral of *Apano Kastro* on Naxos [14]), while the upper part is five-sided.

However, the most prominent western element of the church is its pointed barrel vault. It is about 30 centimetres thick and its clear geometry suggests that it was built with a wooden formwork. A buttressing arch carried on consoles was placed in the middle of the building's long side to strengthen the vault. Since the 1960s the vault is covered with a concrete layer, yet it is safe to assume that originally it had a symmetrical pitched slate-covered roof.

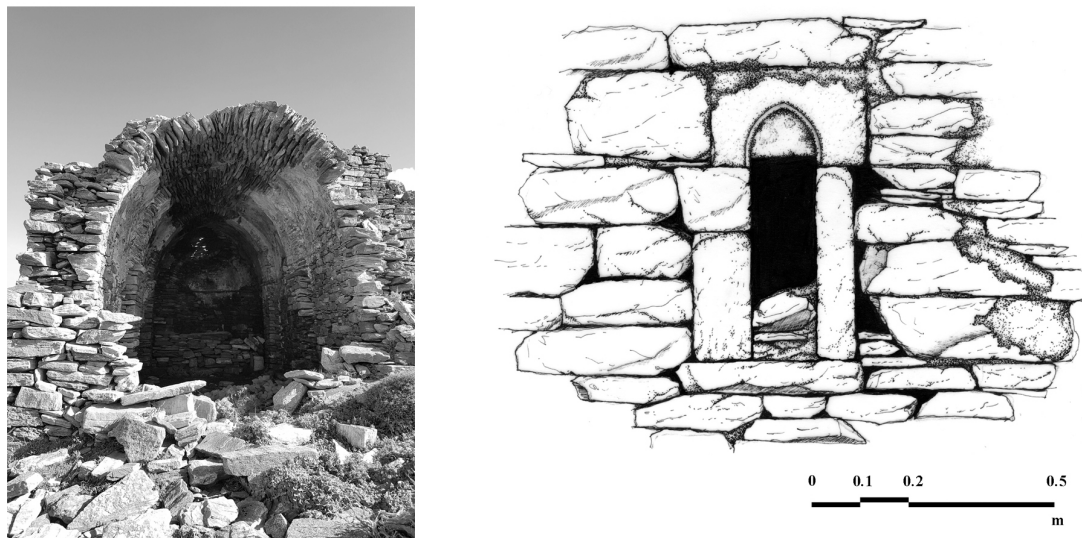
The west elevation of the building is almost gone; however, the remains of the entrance are still visible in the middle of the west wall. In the south wall, there is a small pointed arched window, which narrows outwards. The sanctuary apse is semi-circular measuring 1.95 metres in diameter. At its centre there was a small window formed entirely with dressed stones. Its marble lintel was decorated with a carved pointed arch. (Fig.8) Dressed poros stones were not used anywhere in *Agia Triada*, so maybe the interior was all coated right from the very beginning.

Fig. 8. Agia Triada west elevation and window detail (C. Veloudaki).

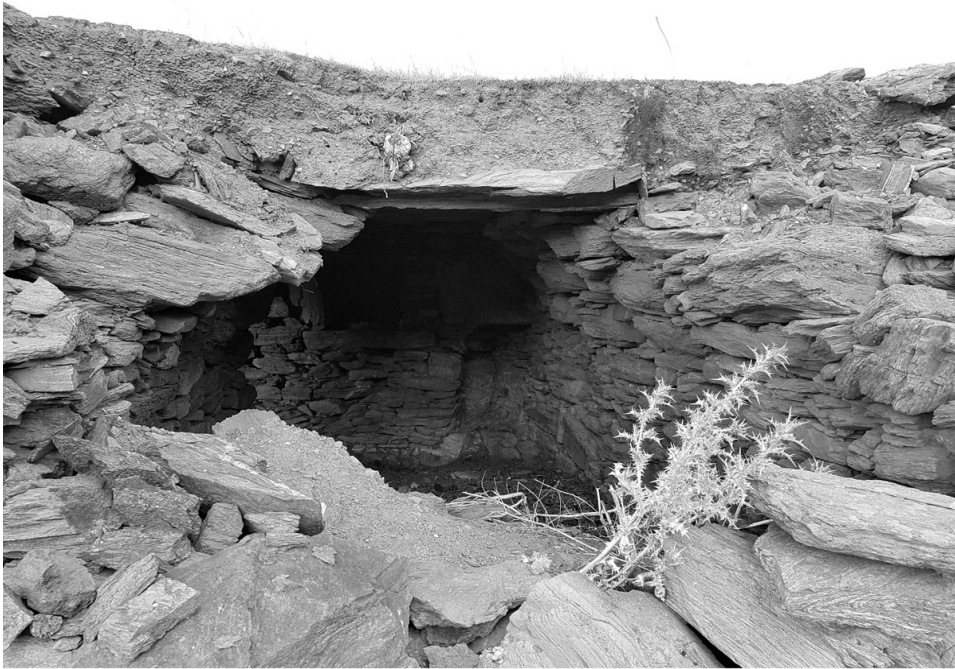
Fig. 10. Rural building in the vicinity of Oria covered with corbelled vault (C. Veloudaki).

All around the island there are also many rural buildings that were constructed with the same building methods. (Fig.10) It is possible that some of them predate the Latin era, however, their dating has never been attempted. In any case, it seems that the new forms and building techniques that were introduced by the new rulers in the thirteenth century were largely adapted to the local vernacular standards as the limited availability of materials and possibly of skilled masons restricted the Latin lord's options. The limitations of the topography i.e. the site's inaccessible location and restricted building space would also have played a crucial role. Nevertheless, the Latins tried to introduce some western elements (pointed vaults and arches) and a certain degree of sophistication (clear geometry, consistent use of headers and stretchers etc.) mainly in the religious buildings and possibly their residence.
